## Case Study

**Client:** Virginia Park, Virginia Water

**Project Title:** Conservatory Fretwork

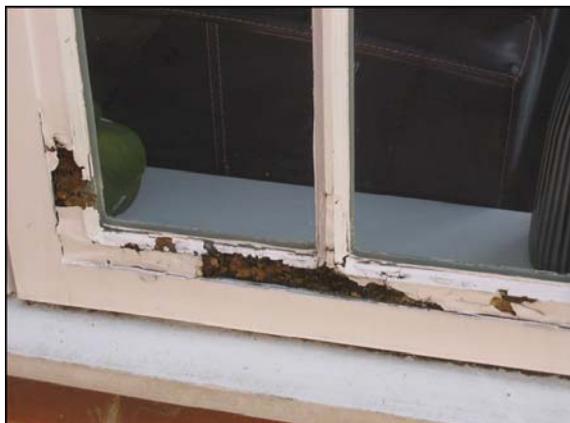
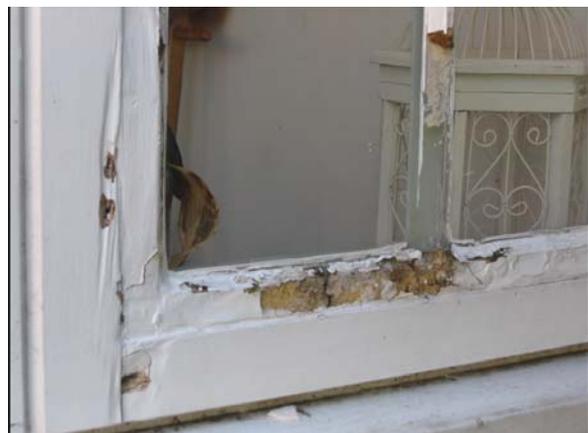
The following case study outlines the process that was undertaken upon Virginia Park's conservatories earlier this year. Our clients approached us to replace the fretwork used within the exterior design of the conservatories. The main problem with the fretwork was rot which had happened in a reasonably short space of time due to the material used: MDF. This material is not designed for exterior use and when we visited one of the homes with this problem we were shocked at how tatty it made the conservatory look.

The removal of the old MDF fretwork panels was carried out as carefully as possible so not to damage the double glazed units underneath. The new panels were then stuck in place upon the glass and sealed all round the edges to help protect them. All new panels were finished with a double coat of primer to help protect the ply from future weathering.

To finish the job to the highest standard we offer a complete conservatory decoration service to blend the freshly painted and finished fretwork in with the interior and exterior colours. Using Bespoke Joinery to finish this section of the job will guarantee your conservatory is brought back up to its original finish with the peace of mind that it is protected from further rot and weathering with the minimum disruption.
